STUDY OF HISTORICAL FLOODS IN CENTRAL AND EASTERN EUROPE FROM AN INTEGRATED FLOOD MANAGEMENT VIEWPOINT

SLOVAKIA

Submitted by: Slovak Hydrometeorological Institute, Bratislava

For the WMO/GWP Associated Programme on Flood Management

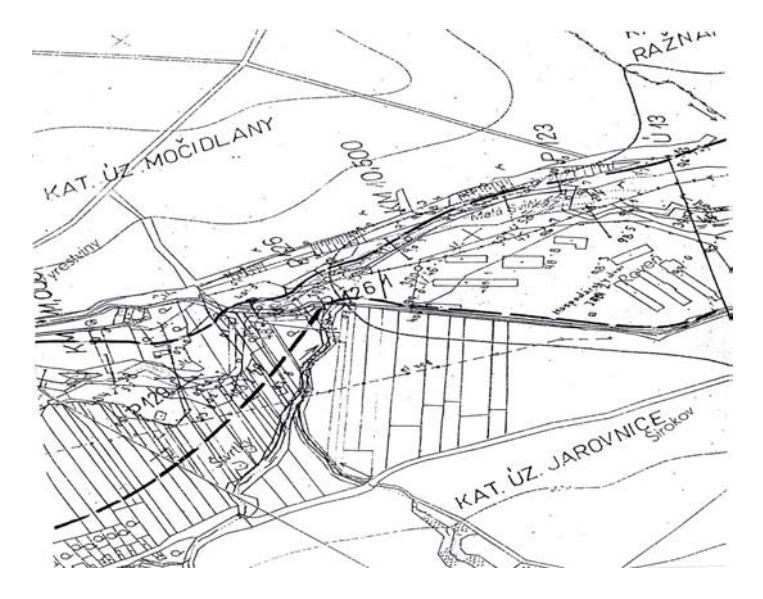
Flooding line of flash flood copied the valley in a whole length of streams. In the places of the narrow valley created backwater with higher water level, here and there more than a several meters. Fig. 5,6,7.

Fig.5. Flooding line in village territory Jarovnice

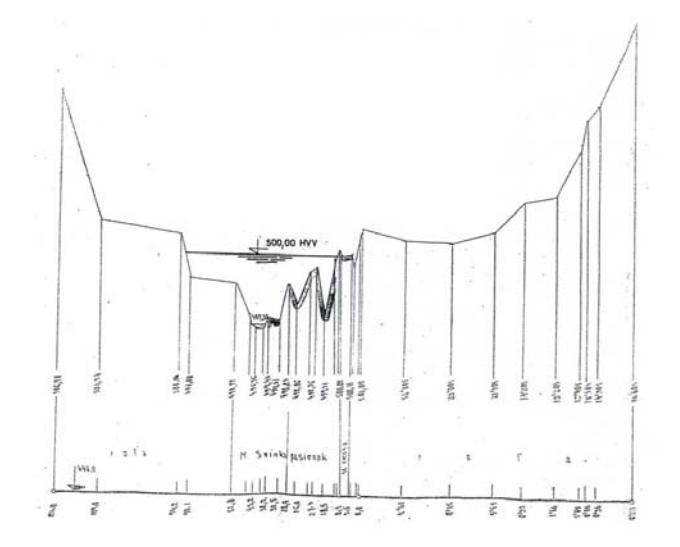
Fig 6. Example of flooding of narrow valley

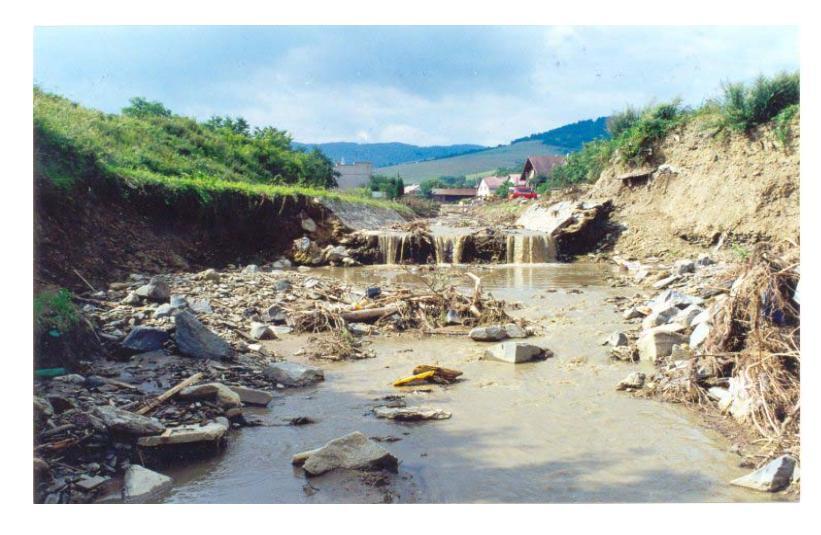
Photo 1: Dubovický creek - The end of stream regulation destroyed by back erosion

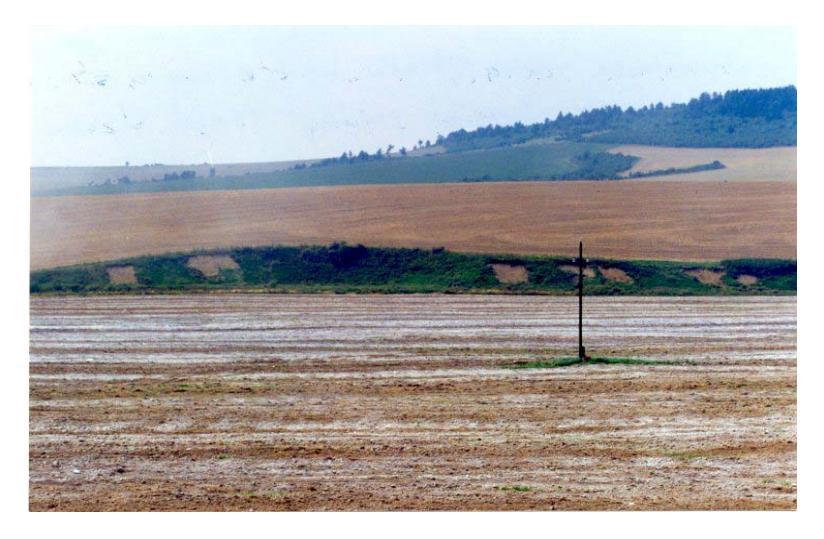
Photo 2: The right slope of valley of Malá Svinka disturbed by slides (above the village Malá Svinka)

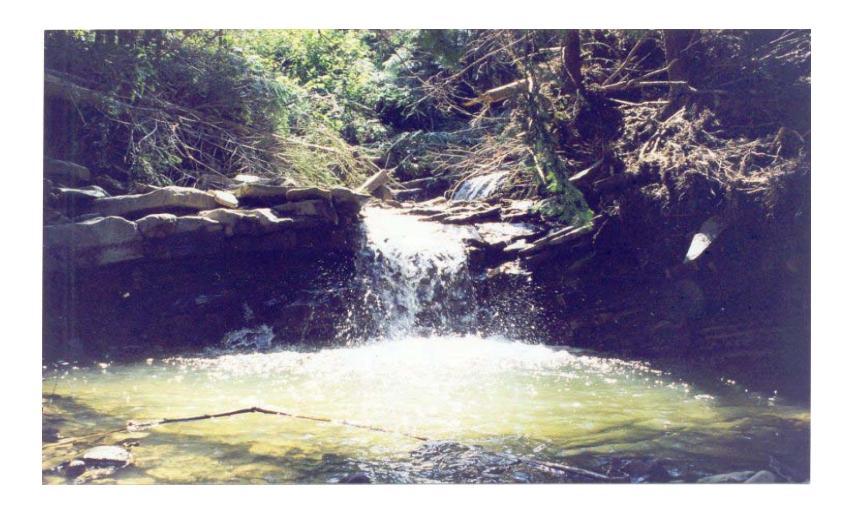
Photo 3: Eroded channel of Malá Svinka down to palaeogenic substratum

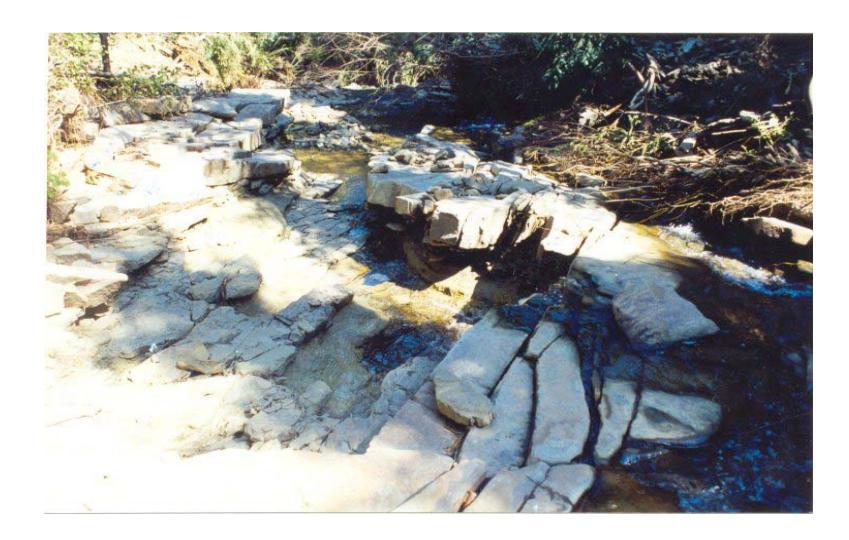
Photo 4: Eroded channel of Malá Svinka down to bed rock (cracked desks of sandstones)

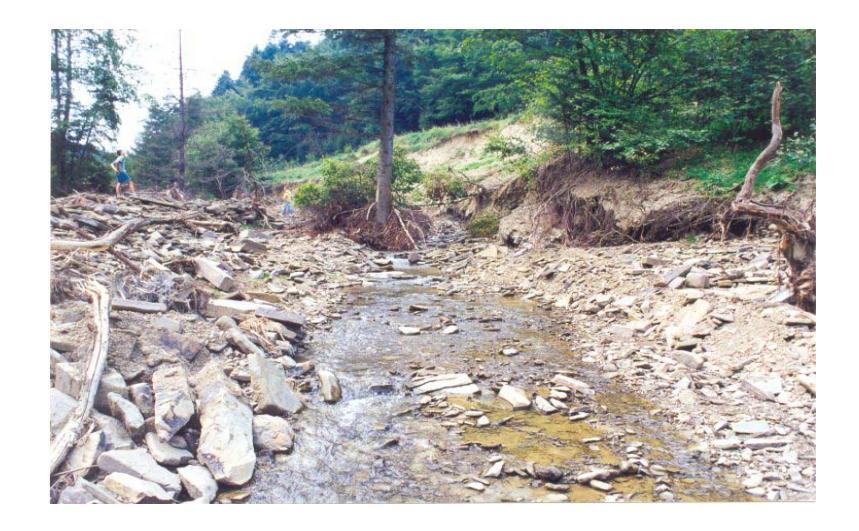
Photo 5: Eroded channel of Malá Svinka (landslide of slope from 5 to 8 m), the creek channel silt up with branches and stones and rocks)

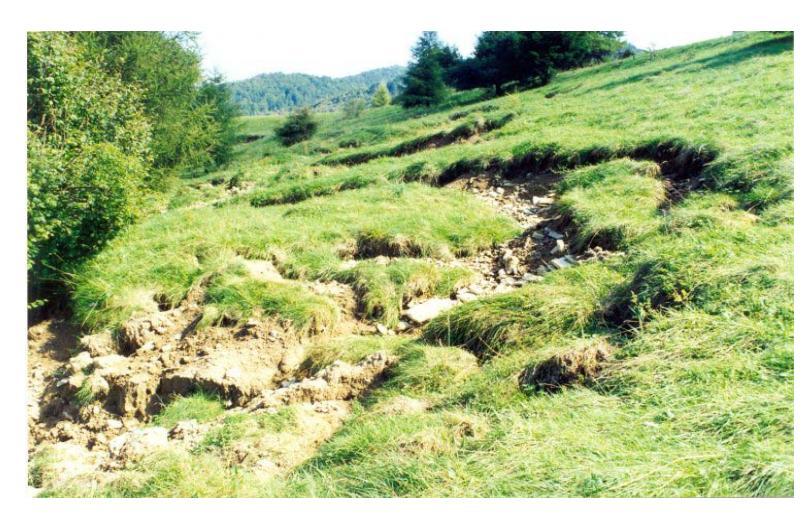
Photo 6: Landslides on the right side of Malá Svinka valley above the village Renčišov

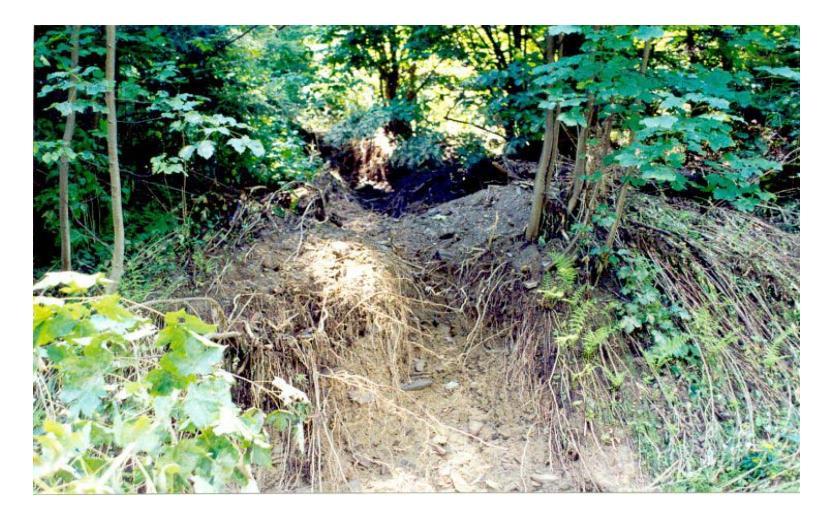
Photo 7: Outfall of the erosive gouge from forest to woods pathway above the village Renčišov

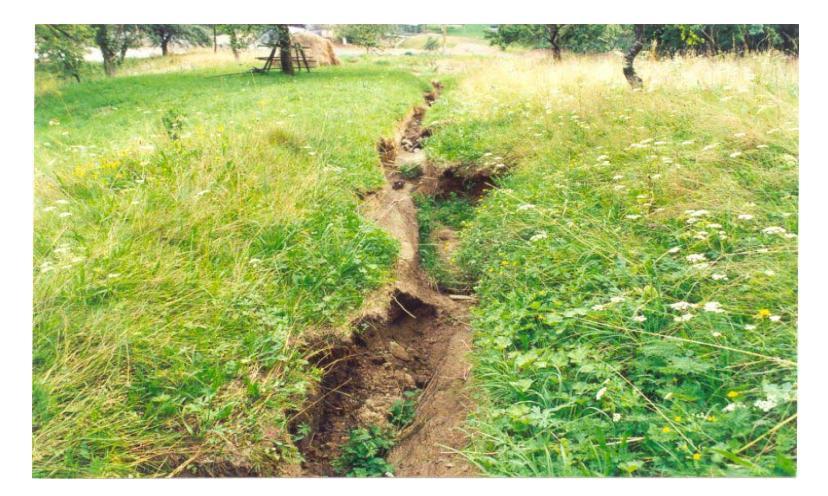
Photo 8: The erosive gouge on the left slope of Malá Svinka valley (the depth 1,5 m) in the village Uzovské Peklany

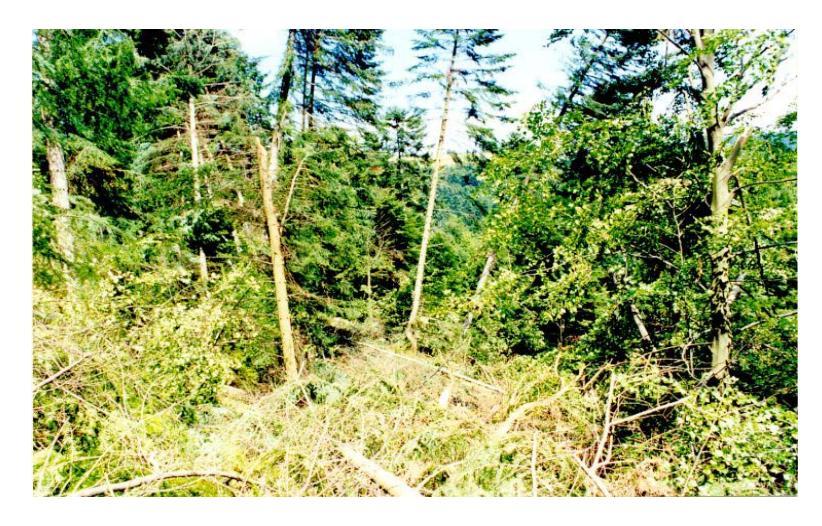
Photo 9: "Walking tress" in the forest touched by erosion

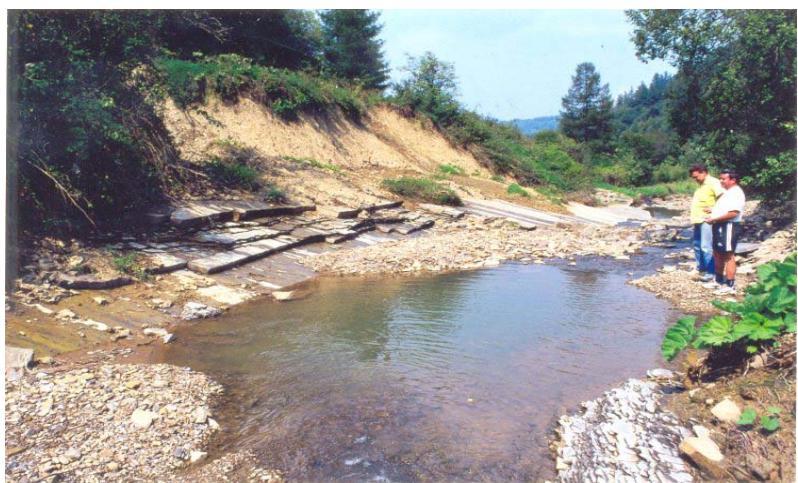
Photo 10: Eroded left bank of the creek channel (down to bedrock) of Renčišovský creek above the village Renčišov

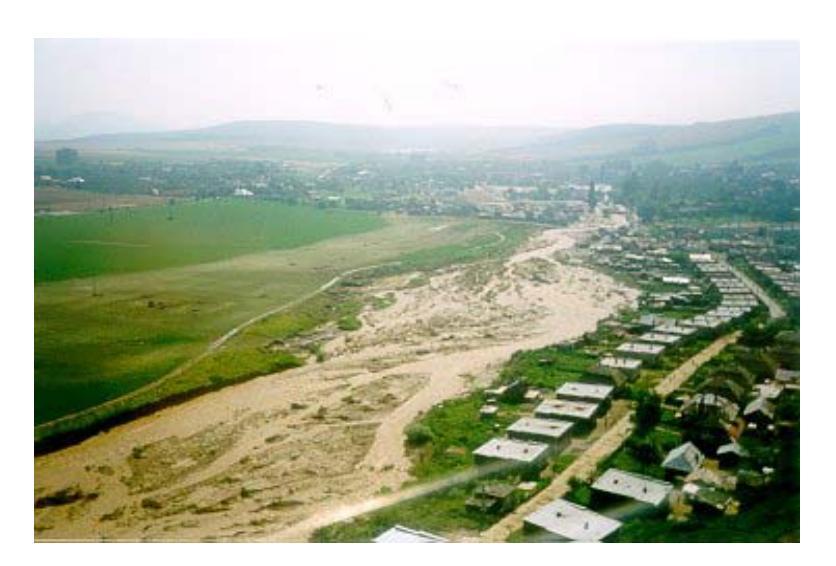
Photo 11: View on flooded village Jarovnice

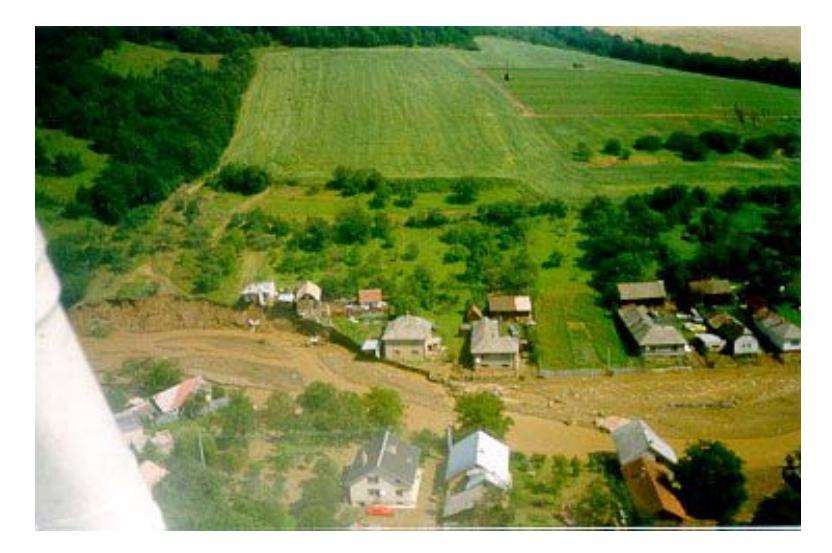
Photo 12: View on the village Uzovské Peklany touched by flood

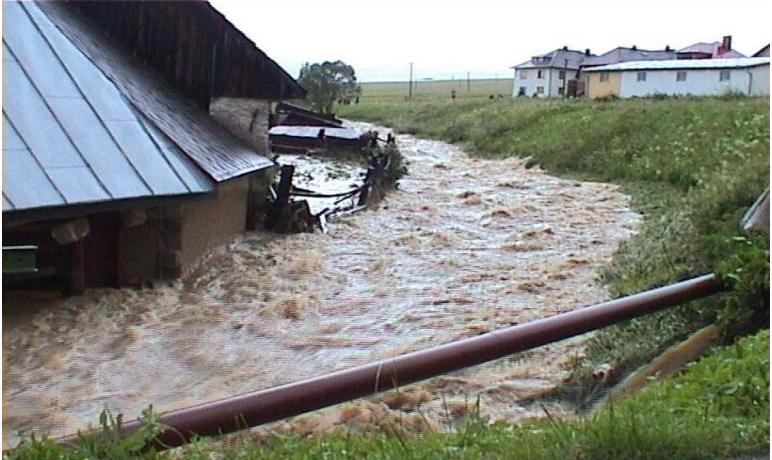
Photo 1. Štrbský Creek - the water level in cross section 1 immediately after culmination

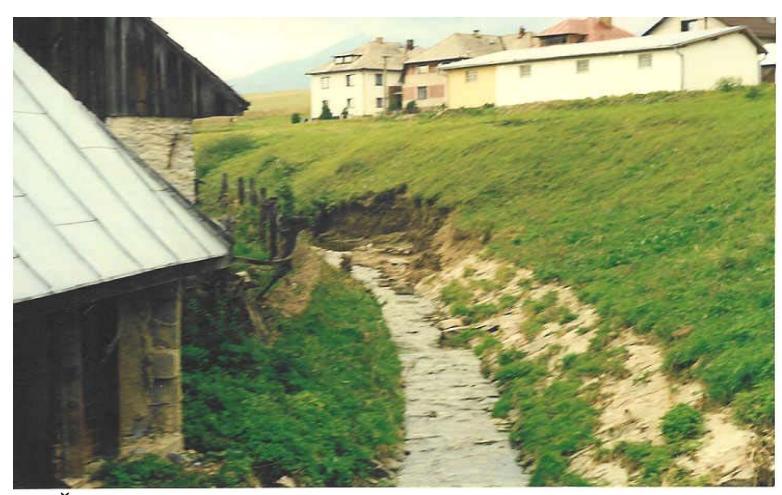
Photo 2.

Štrbský Creek - the water level in cross section 1 ca two weeks after flood

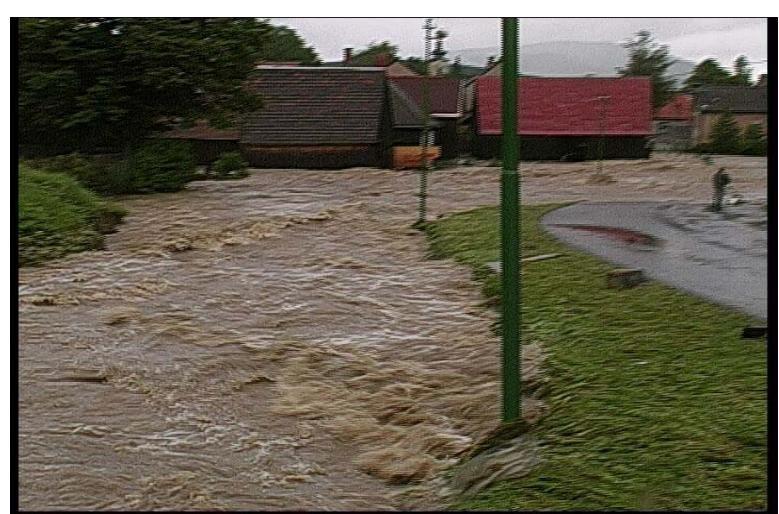
Photo 3. The flood situation on Štrbský Creek in Štrba village

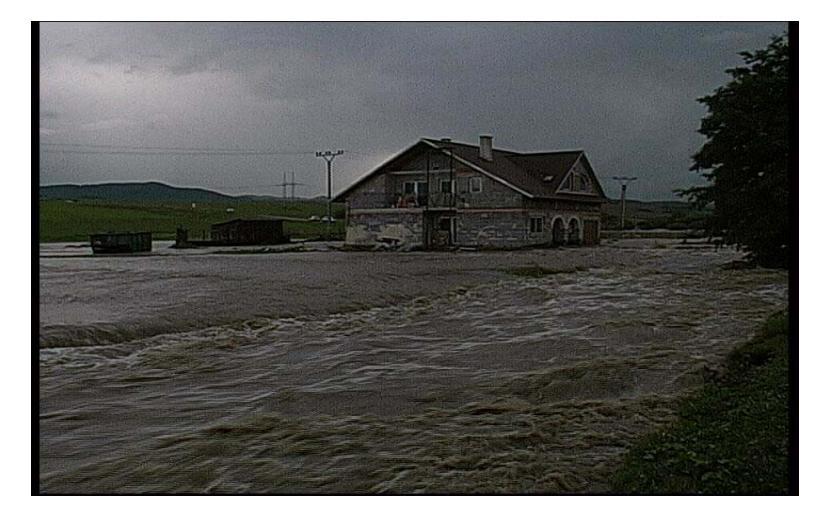
Photo 4. The flood situation on Štrbský Creek in Štrba village

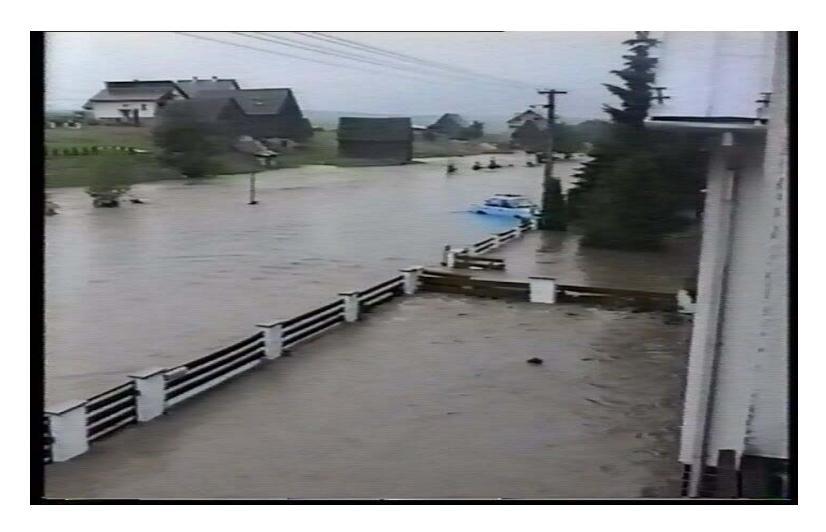
Photo 5. The flood situation on Štrbský Creek in Štrba village

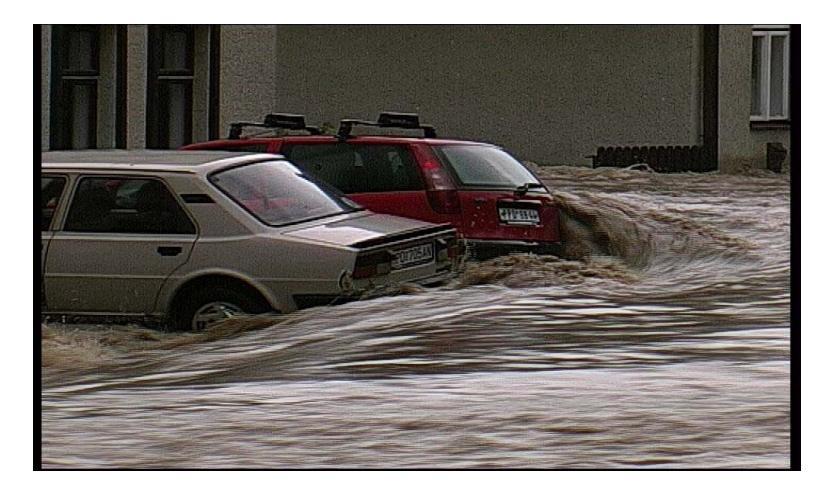
Photo 6. The flood situation on Štrbský Creek in Štrba village
