STUDY OF HISTORICAL FLOODS IN CENTRAL AND EASTERN EUROPE FROM AN INTEGRATED FLOOD MANAGEMENT VIEWPOINT

BULGARIA

Submitted by: National Institute of Meteorology and Hydrology,
Sofia

For the WMO/GWP Associated Programme on Flood Management

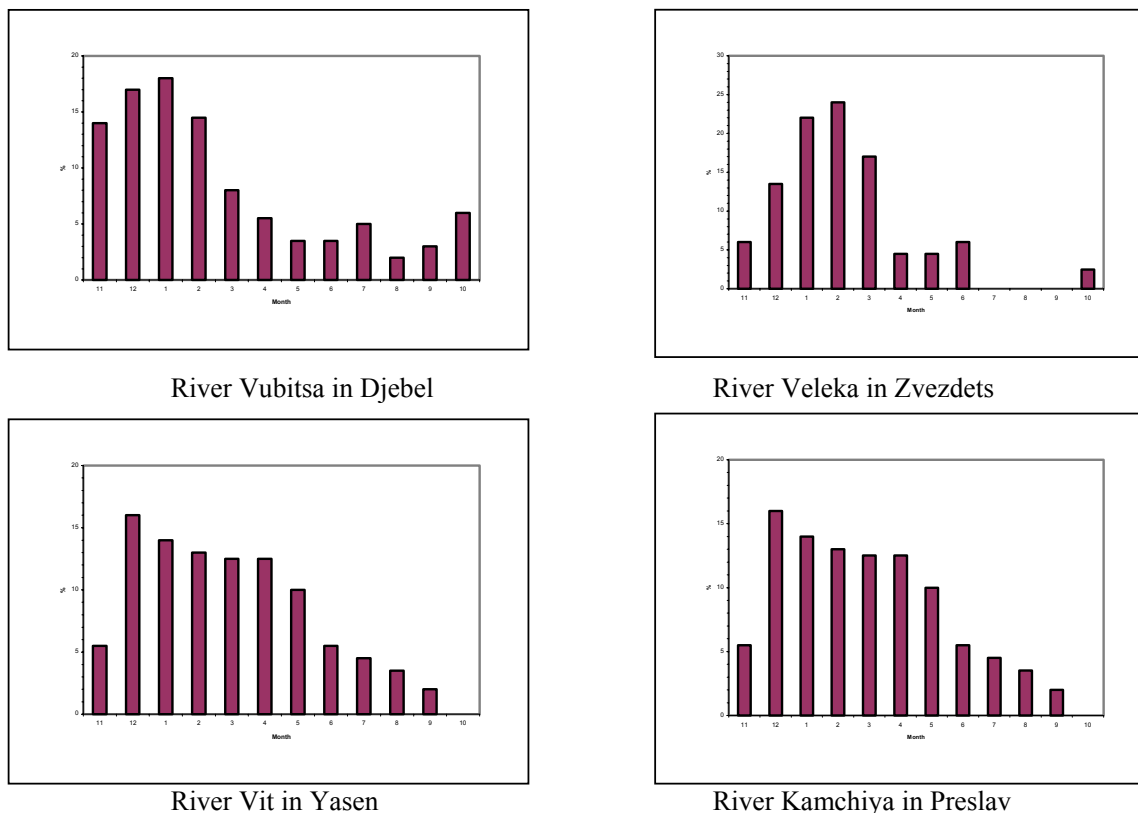
Fig 2. Frequency of floods during the years 1966, 1967, 1968 on different river in Bulgaria

Presented on the figure below is the monthly distribution of the number of floods for several hydrometric stations. The diversity in the climatic conditions and nature factors lead to the formation of torrent floods and corroborated by the different outlines on the indicated diagrams.

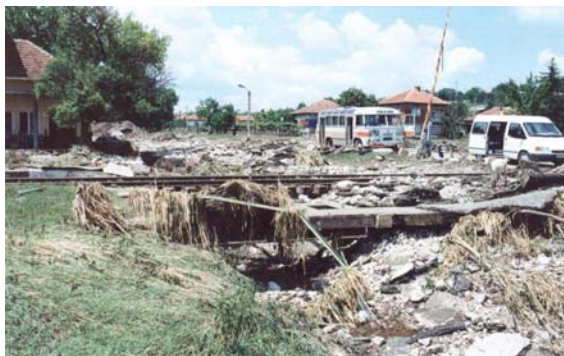
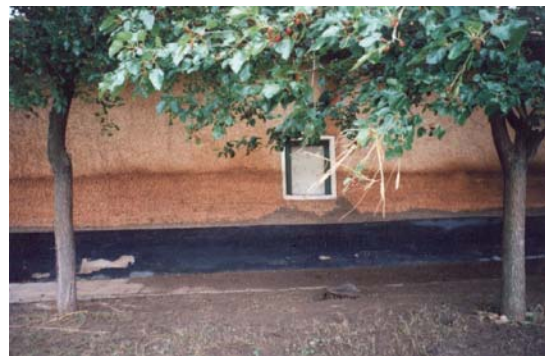
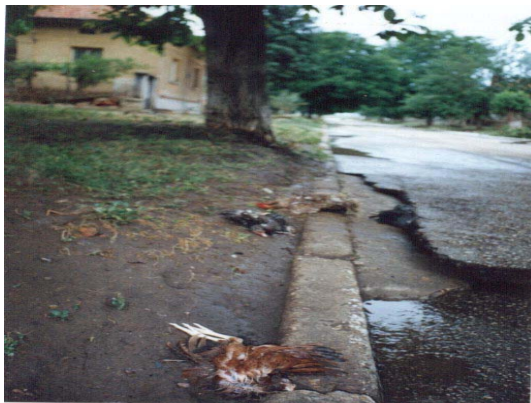
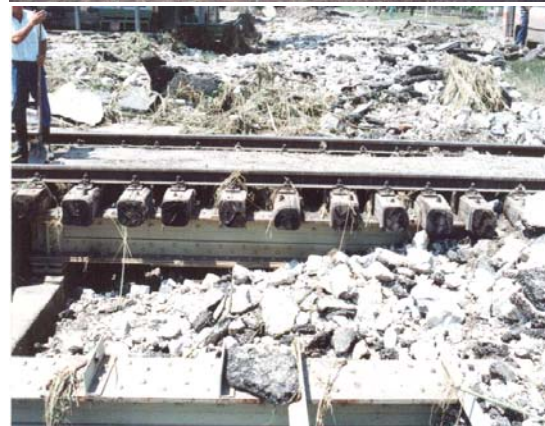
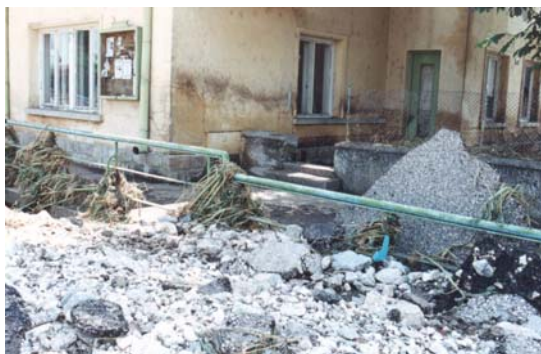
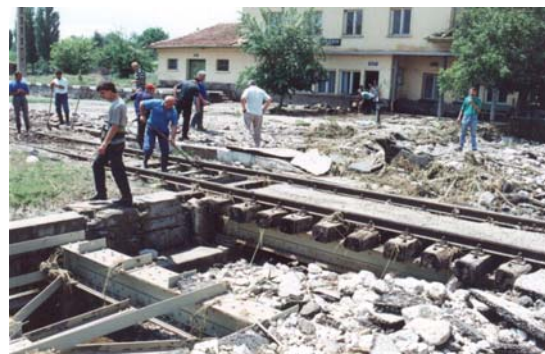
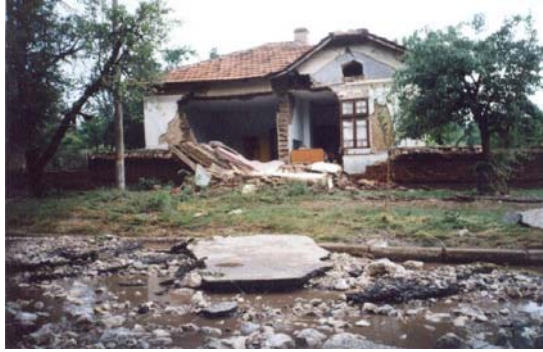
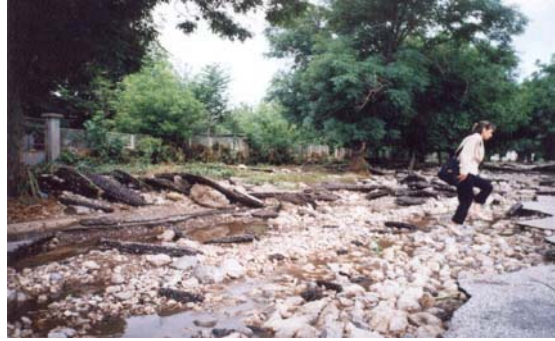
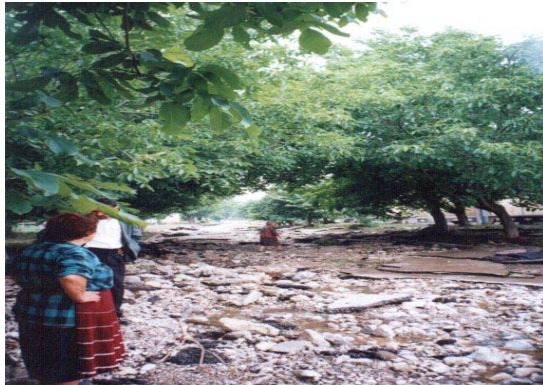
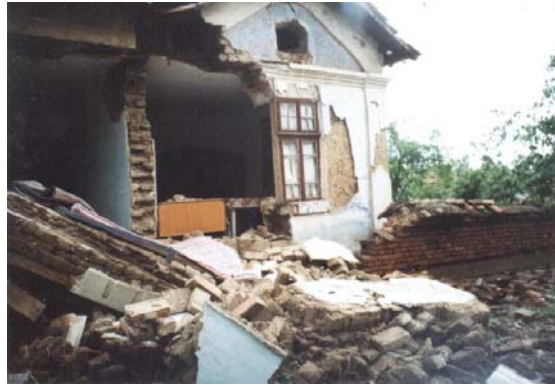
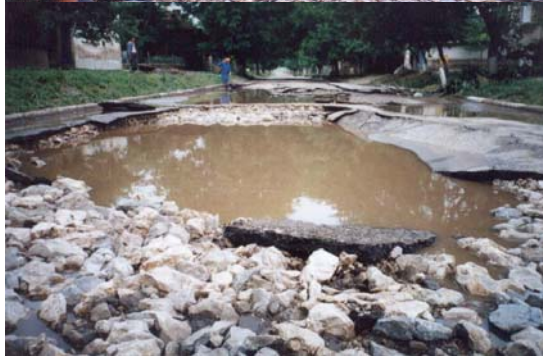
Box 1. Photos of flash floods in the Podem Village - Vit River Basin on June 2002.

- The asphalt and crushed-stone road pavement had been washed away along a strip of 7.80 m in width and 1341 m in length. Part of the demolition goes to a depth of 1.10 m. Some of the dug-out material had been deposited in the lower end of the road at a height of 0.5-0.6 m. At the bridge across the river nearly 1 m deep pits had been formed in a dangerous closeness to its foundations. After the bridge there are another 1081 m of the road cover, whose asphalt pavement had been carried away at a depth of up to 0.2 m and pits have been dug to a depth of 0.9 m. Deposited sediment material had been observed along the road after the pitted section. Some of these piles feature up to 0.5 m in height and 10 to 30 m in length.

rainfall, as a consequence of which the drainage pits and pipelines have been filled over the brim and were no more able to take in the incoming water from the slopes. As a result of their overflowing the water had flooded the upper section of the railroad and the near-by switch and had rushed into the yard of the linesman's lodge. After the withering of the elemental calamity it was found that the drainage pits and pipeline were filled with stone, asphalt pieces, trees and sediment materials. Also recorded were the following damages: demolished railing and railway station platform, clogging of the railroad by sediment materials at a length of more than 150 m, damage on 4 offices at the railway station and the passenger waiting room including the furniture. The basement of the buildings was clogged with sand and sludge. The barrier of the near-by road was demolished.

Illustrated damages in the Box 1. are some of the inflicted on this area by the described flood.

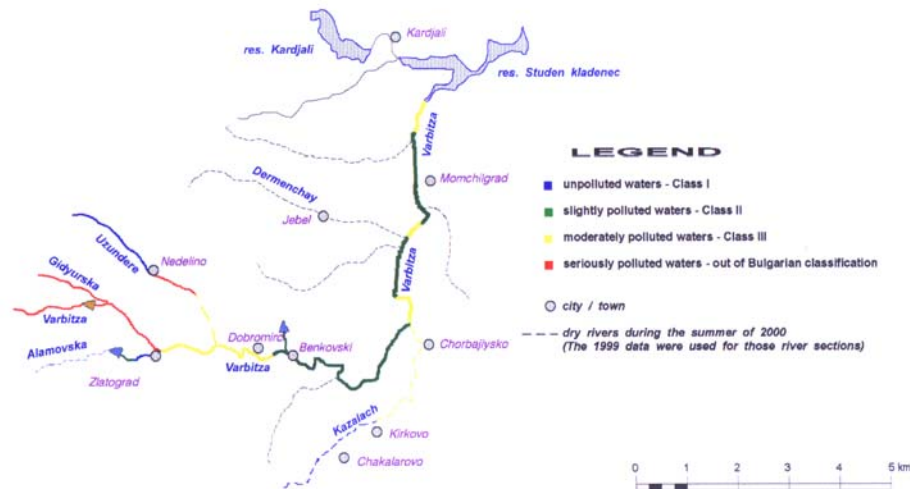
Fig. 5. Biodiversity of the Varbitza River basin.

For the most cases, the Arda River indicators of dissolved oxygen, BOD₅, and permanganate oxidation comply with the surface water quality norms of I and II categories. There were episodic suspended solids high concentrations measured mainly in rains and floods periods. A local hot spot of Arda River is Varbitsa River before the tailing depot of Gorubso-Zlatograd AD. There is a pollution with heavy metals from the mines in the area. The biological monitoring of surface water in Varbitsa river basin is shown in Fig.5.
