# STUDY OF HISTORICAL FLOODS IN CENTRAL AND EASTERN EUROPE FROM AN INTEGRATED FLOOD MANAGEMENT VIEWPOINT

CZECH REPUBLIC

Submitted by: Czech Hydrometeorological Institute, Regional Office,  
Brno

For the WMO/GWP Associated Programme on Flood Management

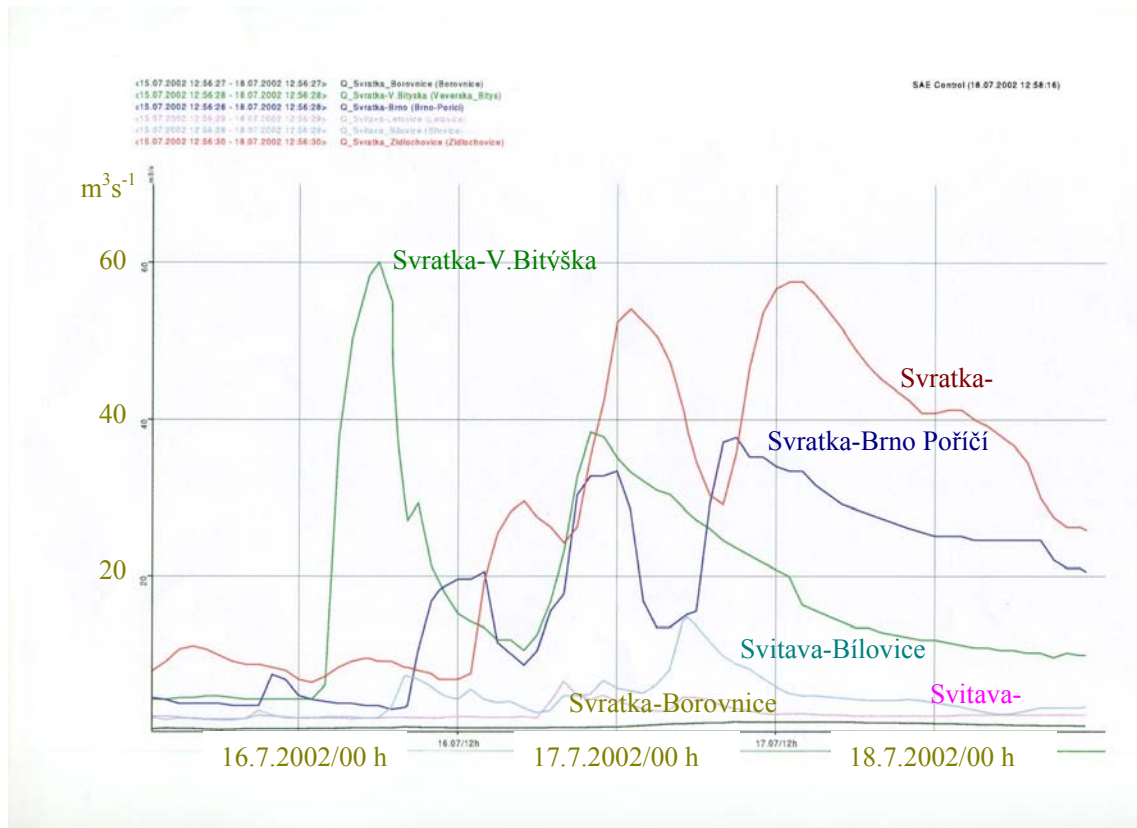
## Hydrograph

As can be seen from the hydrographs, a greater response to the torrential rainfall was manifested in the Svratka catchment, while the Svitava catchment was affected substantially less. In the Svratka catchment, the left hand tributaries registered maximum discharges with a return period greater than 200 years, while in the Svitava catchment the most affected were right-hand tributaries Petrůvka Creek and Úmoří Rivulet,

### Average hourly discharges Svratka and Svitava 16.7. – 18.7.2002

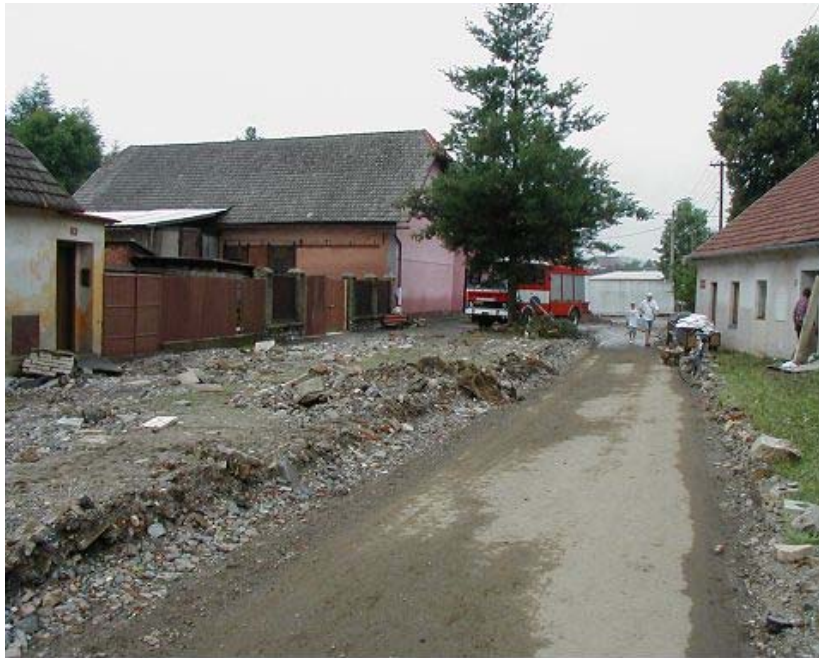
### Township of Olešnice – Veselský Creek in piping on the 16.7.2002

Deposits of gravel, clay and small stones in the low part of the township under the dairy. The high water mark can be seen on the houses on the right. The road has already been scraped. The maximum discharge here has been evaluated to be  $27 \text{ m}^3/\text{s}$ .

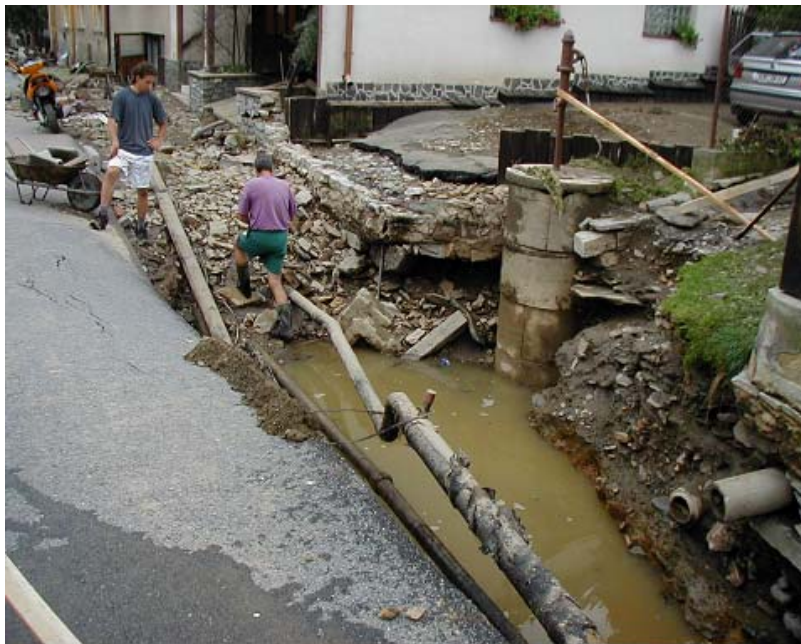
The affected part of the township, street below the dairy, a scour hole about 2 m deep. The Veselský Creek is piped under the road.

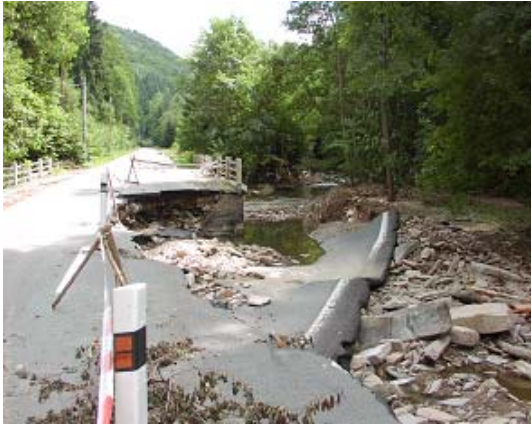
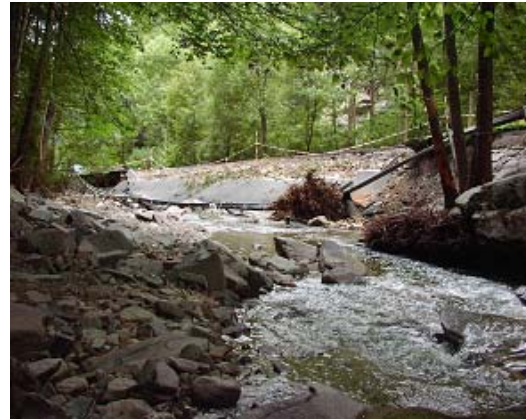
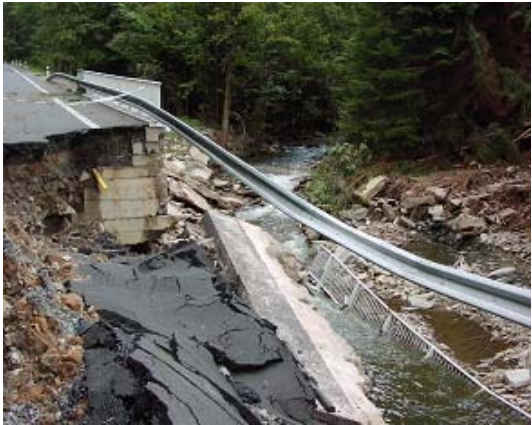
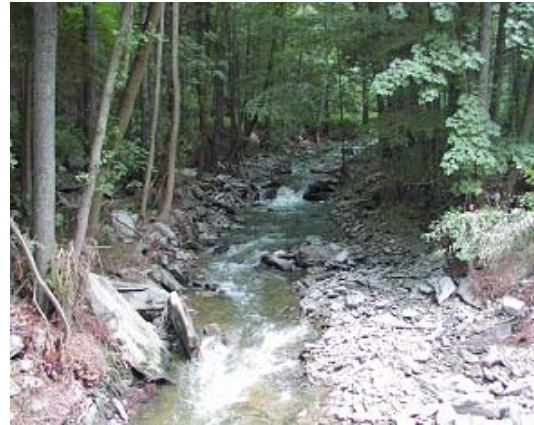
**Road between Hodonín u Kunštátu and Štěpánov – Hodonínka Rivulet on the 22.7.2002**

Damaged road and bridges between Hodonín u Kunštátu and Štěpánov in a section approximately 7 km long, where the average water velocity ( $v_{ave}$ ) reached 4 m/s.

Flood-caused damages to property, which comes under the Administration and Upkeep of Roads in Blansko, was preliminarily estimated by road experts to be 25 to 30 million Czk. The most serious damage was a completely destroyed bridge on a road of third class between the villages of Olešnice and Hodonín. Only about a metre footbridge was all that remained from the road bridge. Among other damaged road sections was the road between the villages of Rozseč and Kunštát, on the main road connecting Žďár nad Sázavou, Boskovice and Prostějov. About 10 km of roads were damaged. More damaged were local roads, in some villages the footpaths and local road were completely obliterated. The Žďár region had large road damages.
