# STUDY OF HISTORICAL FLOODS IN CENTRAL AND EASTERN EUROPE FROM AN INTEGRATED FLOOD MANAGEMENT VIEWPOINT

ROMANIA

Submitted by: National Institute of Hydrology and Water Management,  
Bucharest

For the WMO/GWP Associated Programme on Flood Management

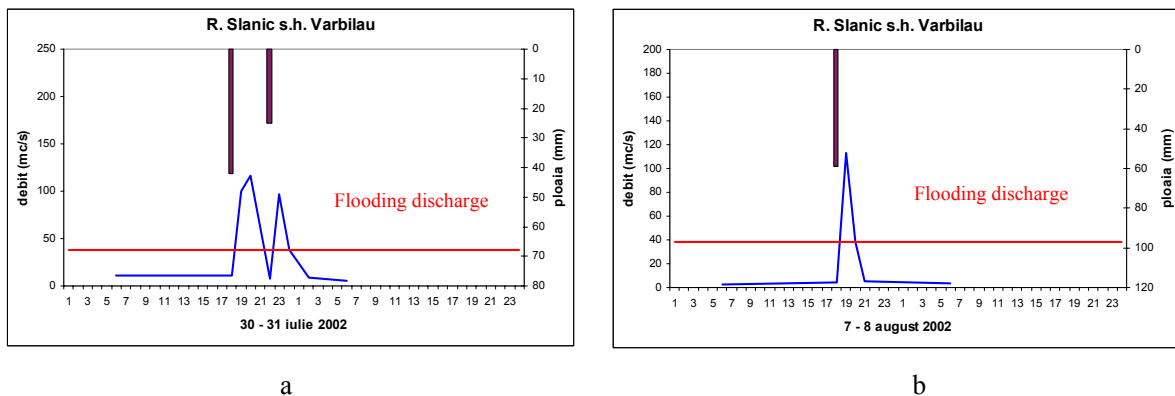
Fig 2. Flash floods on Slanic river at Varbilau gauging station

These precipitations amounts led to significant increases of the waters level, the peak of the maximum discharge being reached in one hour. The peak discharge on Slanic river – Varbilau gauging station has the exceeding probability of 1% with the value of 113 m<sup>3</sup>/s (fig. 2 - b) and the level was 300 cm.

Before this flood on 30-31 July, there was another strong flood caused also by high amount of precipitation. (Fig 2 – a). The two floods succeed at short periods of time, a series of torrents being activated by rainfall and a lot of slopes runoff was recorded.

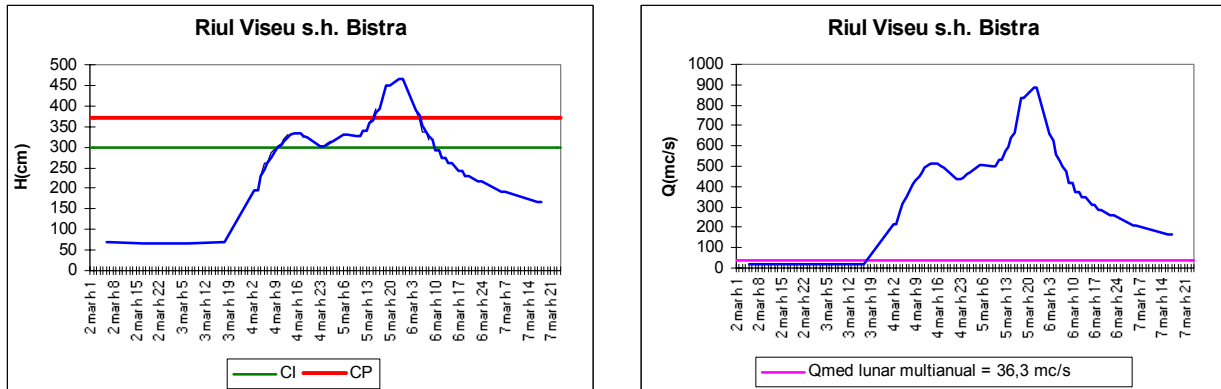
Fig 4. Flood on the interval 3 – 7 March 2001 on Viseu river, Bistra gauging station

From the hydrological point of view, the year 2001 was characterized by a flow slightly over the multiannual mean for most of the rivers in the west and north of the country. In the winter seasons, significant discharge increases, were mostly determined by the superposition of rainfalls, with a rapid snow cover melting, following the sudden rise of temperature. The most important discharges were recorded during the 3-7 March interval, on some of the most important rivers from the northern half of the country. The exceeding probability of the maximum discharge on Vişeu river – Bistra gauging station (fig. 3) was 3% and its value was 886 m<sup>3</sup>/s. The maximum level was 465 cm and the danger level was exceeded with 95 cm (fig. 4).

CI – flooding level  
 CP – danger level.

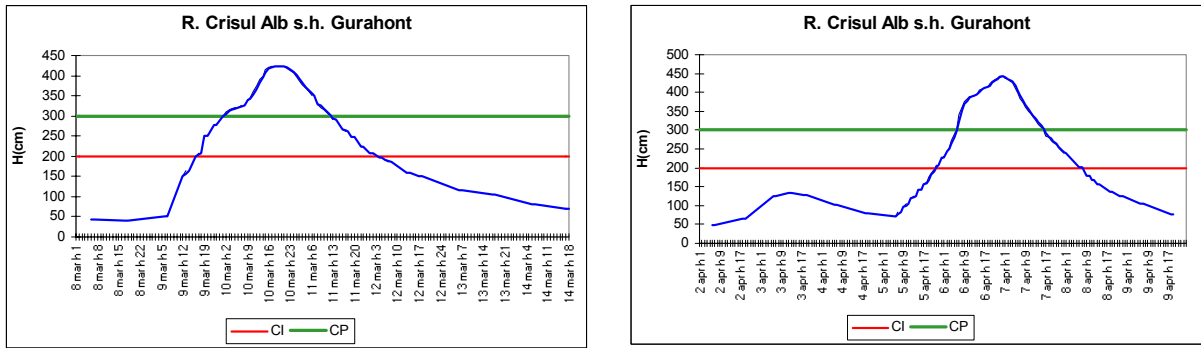
Fig 6. Floods on the intervals 8-14 march 2000 and 6 – 11 April 2000 on Crisul Alb river,

8-14 march 2000

6-11 april 2000

CI – flooding level  
 CP – danger level

Maximum discharge recorded on the Crisul Alb by the hydrometric network of the river on april 2000 had the exceeding probability of 2% with the value of  $586 \text{ m}^3/\text{s}$ . The level of the water was 442 cm overpassing the danger level (fig 6). Because of these maximum discharges a break in the right shore dam of the River Crisul Alb was produced, 2 km downstream the confluence with the river Cigher. The width of the break (generated by the flow of the water) varied between 70 m at 7.04.200 – 17:00 h and 147 m
