STUDY OF HISTORICAL FLOODS IN CENTRAL AND EASTERN EUROPE FROM AN INTEGRATED FLOOD MANAGEMENT VIEWPOINT

SLOVAKIA

Submitted by: Slovak Hydrometeorological Institute, Bratislava

For the WMO/GWP Associated Programme on Flood Management

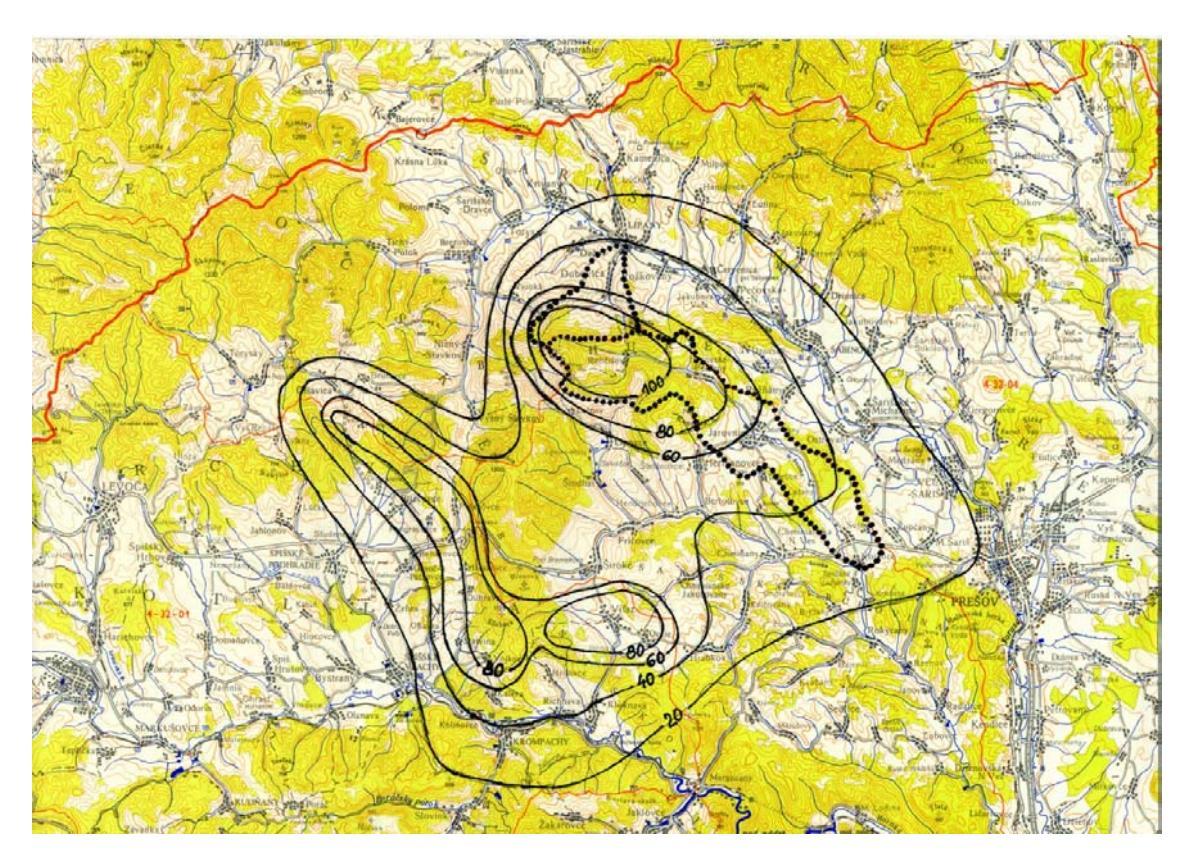
Fig. 3 Reconstructed field of torrential rain during the flash flood on July 20, 1998

The terrain investigation was aimed at flood marks after spilled water from creek banks and marks after heavy rain on meadows and fields. The marks were categorised, what was the basis for isohyets construction. (Fig. 3)

The core of torrential rainfall (cloudburst) did not touch any rain gauge station. The thunderstorm in this region had more cores with different trajectories and different time of beginning. On more places inhabitants watched strong wind or gustiness, special sound effects and hails.

In this region the 24-hour precipitation total with probability of occurrence 0, 01 (once in 100 years) is app. 80 - 90 mm. In the most vulnerable areas precipitation reached app. 100 - 130 mm during 150 min. The rainfall duration on precipitation gauging station Lipovce in the watershed Svinka was recorded from 16,10 to 17,45. The most intensive precipitation occurred in time interval 10 to 30 minutes.

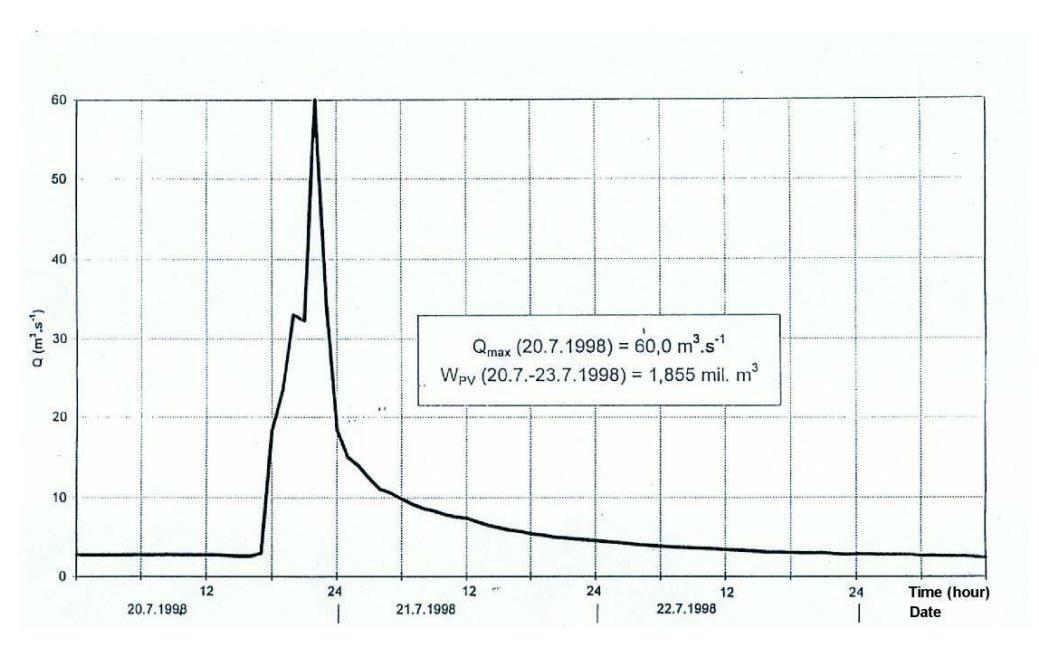
Fig. 4 Hydrogram in water gauging station Sabinov (Torysa river), July 1998

The basic material used for reconstruction of the flash flood on Malá Svinka and Dubovický Creek was record from the water level gauging station on Torysa River in Sabinov. This station is located just below the confluence with Dubovický Creek. Because of fact that the rainfall did not affect other part of the Torysa River Basin, the water volume of the wave in Sabinov might be considered as volume strongly related to the flood in Dubovický Creek. (Fig. 4)

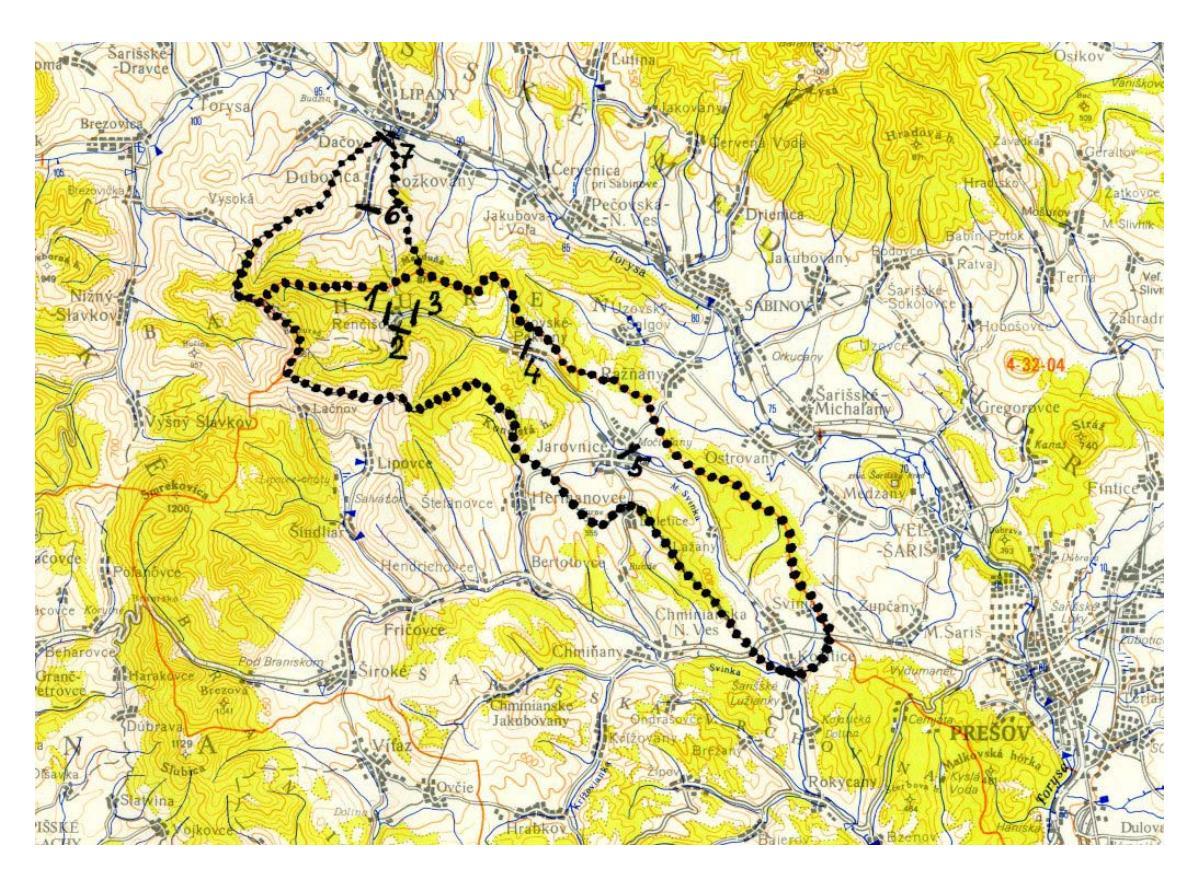
Fig. 8 The cross-sections with evaluated flash flood

Based on the theoretical assumptions and reconstructed flood waves, it was found that in the villages Renčišov, Uzovské Peklany, Jarovnice and Dubovica in the local streams 1000- years discharges were occurred. Destroying energy from the flowing water rather significantly decreased by the wave transformation in the inundation area downstream Jarovnice village. This energy decrease of the flowing water caused the sedimentation of the suspended matter and flowing materials. As a result of the flood wave reconstruction, the following series of the culmination of discharges and volume for 7 most damaged localities can be presented (Fig. 8):

- 1. Malá Svinka in cross section above Renčišovský Creek
 - Estimated maximum culmination discharge 90 m³.s⁻¹
 - Estimated volume of the flood wave 400 000 m³

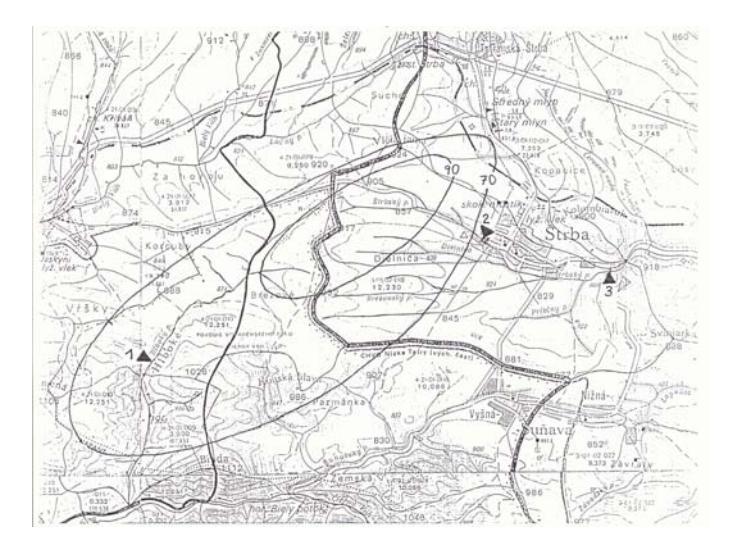
Fig 8. Isohyets of torrential rain in the catchment of Štrbský Creek

Measured rainfall total was 73,6 mm near the location of the first cross section on Štrbský Creek. According to information, the whole rain continued circa 55 minutes, however 95% of precipitation fell out during 30 minutes. This fact was confirmed also by video record, which started at 15,50.
